# Hinkley Center Report on FlowMark Leachate Treatment

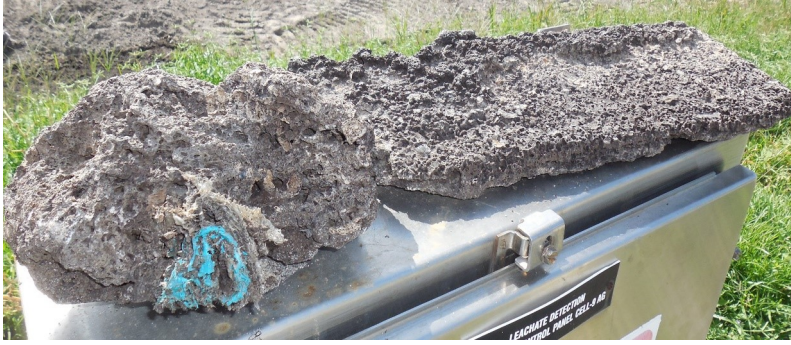
Leachate scale samples prior to installing the FlowMark submersible system in manhole number 11. The 8" gravity main collection pipe would scale completely closed in two months requiring frequent hydro-blasting and acid cleaning.

**Following 22 months of FlowMark treatment the gravity main pipe remains free of scale.**
