FlowMark Pulse Power Eliminates Hard Rock Calcite Scale in Clean Steam Boilers Providing Steam to for Steam Rooms

Eliminate Hard Rock Calcite Scale on Steam Boiler Heat Exchangers

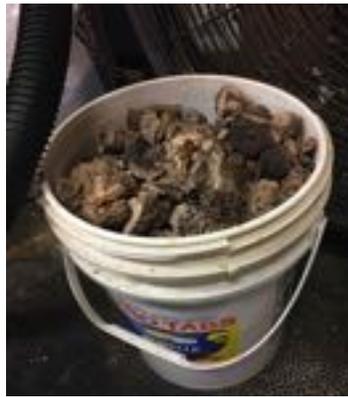
Calcite Scale Manually Remove from Boiler #1 with hammer drill

Calcite scale is a problem with clean steam systems especially on heat transfer surfaces such as steam boilers or heat exchangers. The calcite scale causes:

- 1.) Fouling of equipment
- 2.) Increases energy use
- 2.) Causes additional expenses relate to heat exchanger replacement
- 3.) Difficult & time consuming to remove calcite scale often with a hammer drill

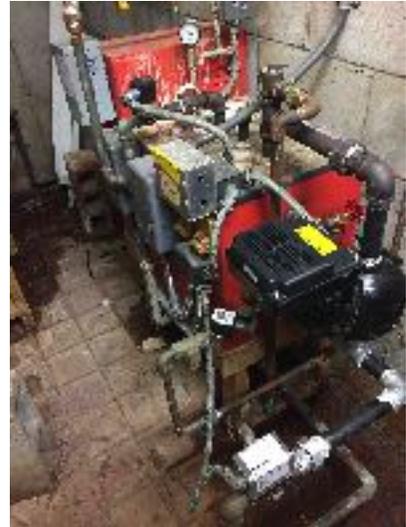
Dedham Health & Fitness Complex – One of Two Clean Steam Boilers

Conservation Solutions Corporation installed a FlowMark electronic resonance pulse power water treatment systems on the water supply before two steam boilers. Boiler #1 had been cleaned and Boiler #2 had scale causing fouling.

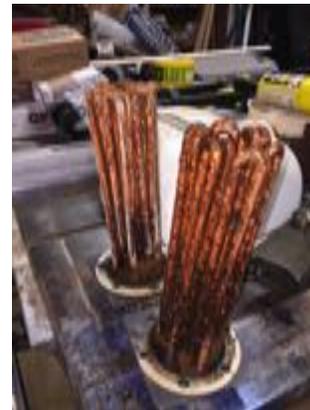
Heat Exchanger Elements heat transfer surfaces clean of scale after 3 months with FlowMark System

The FlowMark Pulse Power System change the way calcium forms. Instead of creating a hard rock calcite scale, the calcium precipitates on the particles in the water to make a powder, which is either filter out in a filtration system or flows through the system to the steam room.

The FlowMark System also removes existing scale over time. Expansion & contraction occurs in the boiler with cracks forming in the calcite scale. Under normal conditions, the calcite would fill the cracks enabling the calcite scale to build-up. Using the FlowMark System, these cracks are no longer re-filled with calcite scale and the exiting scale eventually falls off. The existing scale also becomes softer and easier to remove. Calcite Scale is eventually eliminated from the heat transfer surfaces providing a long-term sustainable energy efficiency solution preventing future calcite scale from forming.
